UNITED STATES ENVIRONMENTAL PROTECTION AGENCY
REGIONS 5
77 WEST JACKSON BOULEVARD
CHICAGO, IL 60604-3590

RE: Administrative Order V-W-04-AO-17

**UNITED STATES ENVIRONMENTAL PROTECTION AGENCY
NPDES INSPECTION**

A. Facility Name and Address: Milco Dairy, LLC
(b) (6)

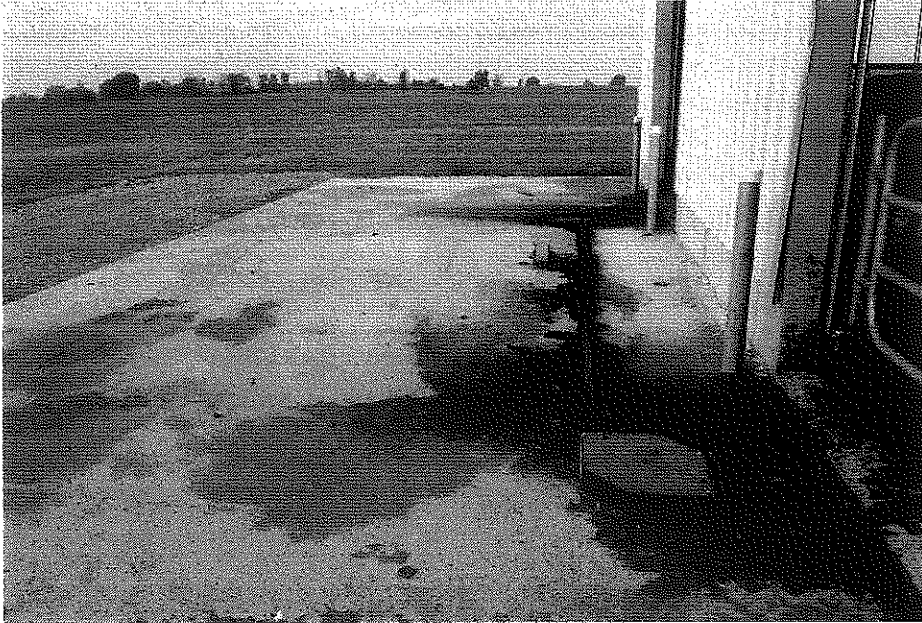
Photo 1: Front of the freestall barns, which shows the added amount of waste that is scraped out of the barns with the automatic scrapers.
Facing: North

1. Continual clean up of the cement pads is required on the west side of the freestall barns especially before anticipated precipitation events. This action should be recorded on the self-inspection forms.

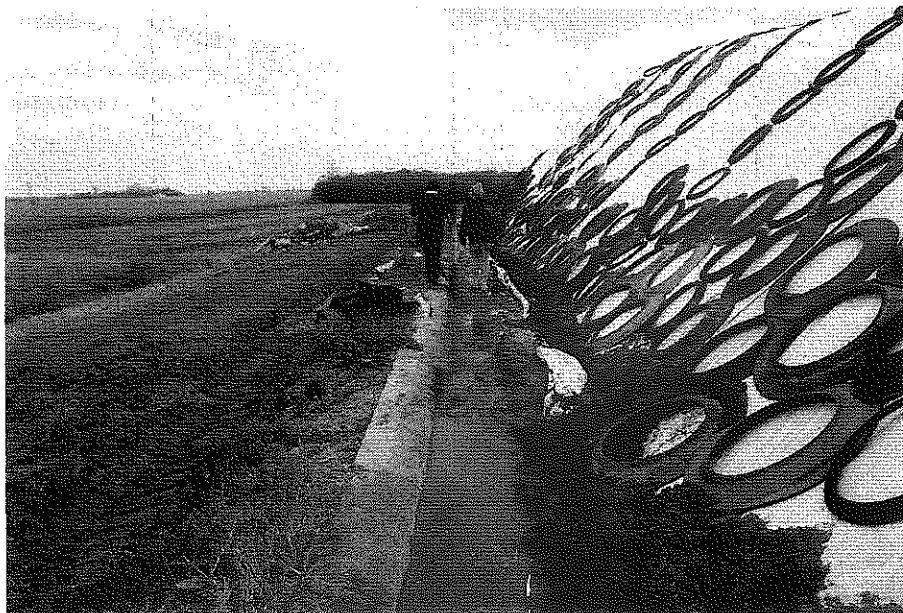
1. Milco Dairy cleared the excess silage from the east side of the silage pad to allow for the precipitation to drain to the south into the new process wastewater pond. This appeared to have corrected the problem of the discharge of process wastewater to the unnamed tributary. However, the silage was discarded to the east of the silage pad, which during a precipitation event will discharge into an unnamed tributary. This was explained to Mr. and Mrs. Niessen, who indicated that it would be corrected.

Yes, the deficiency with the silage pad discharging was corrected; however, excess silage was not properly removed. The excess silage was cleared, by discarding it on the eastern side of the silage pad, which discharges into an unknown tributary. This was mentioned to Millie and Nico Niessen, Owner/Operator of Milco Dairy. Millie explained that the contractor discarded the excess silage without their knowledge and will make sure that it correctly discarded next time.

Photo 2: Walking on the east side of the silage pad, U.S. EPA inspectors noticed that a pathway had been cleared to allow for process wastewater to drain to the south. However, the excess silage was discarded on the east side of the berm, which during a precipitation event would allow the discarded silage to discharge into the unnamed tributary to the east.
Facing: South

2. The excess silage that was cleared from the eastern side of silage pad was discarded to the east of the silage pad, which will discharge into the unnamed tributary.

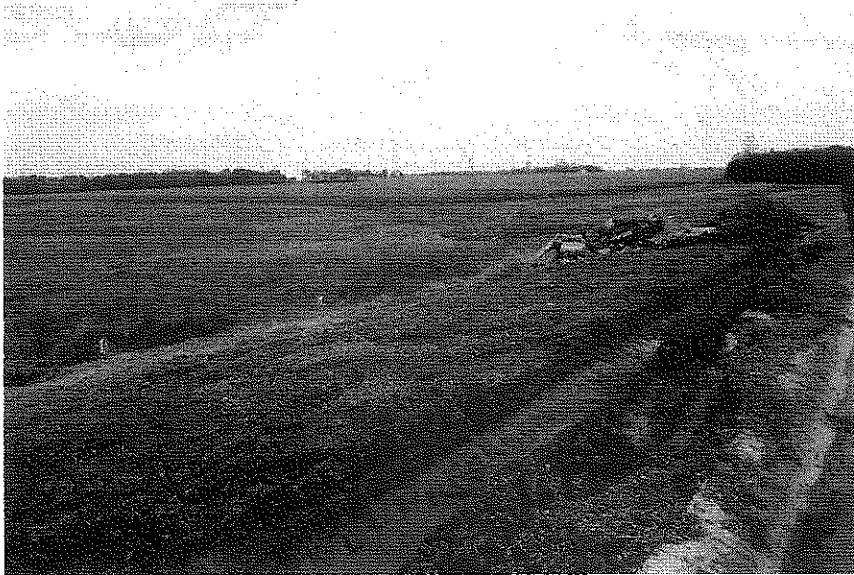
Photo 3: Close up of the excess silage that was discarded from the silage pad to allow process wastewater to flow around the back of the silage pad and into the process wastewater pond.

- c. If overfilled, proper disposal of excess silage is required.
6. Record on the laboratory sheets the method of analysis for the soil sampling done on the land application fields.

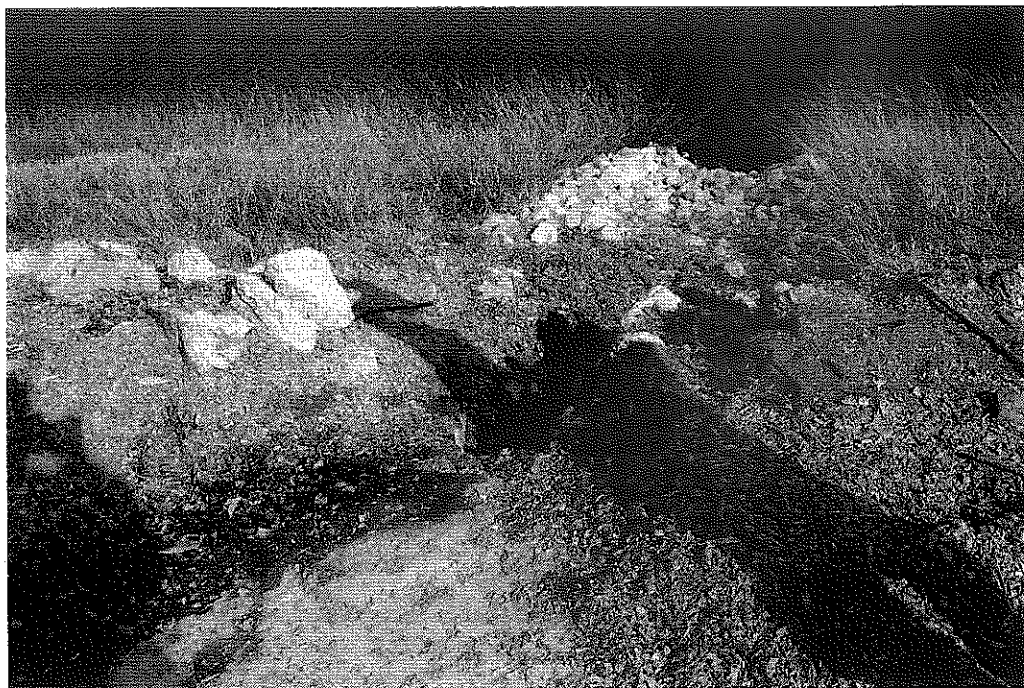
2. At the time of the inspection, there was a leak along the southeastern side of the silage pad that had been contained by discharging into the process wastewater pond; however the eastern side of the silage pad still needs to be inspected regularly for other leaks, to ensure that that process wastewater does not discharge to the unnamed tributary.

Photo 4: Close up of crack in the berm of the silage pad draining into the process wastewater pond.

- a. Checking for cracks in the cement berm, to ensure that discharges are not occurring.
 - b. Managing the silage so that the pad is not overfilled and allowing discharges of the pollutants to occur.

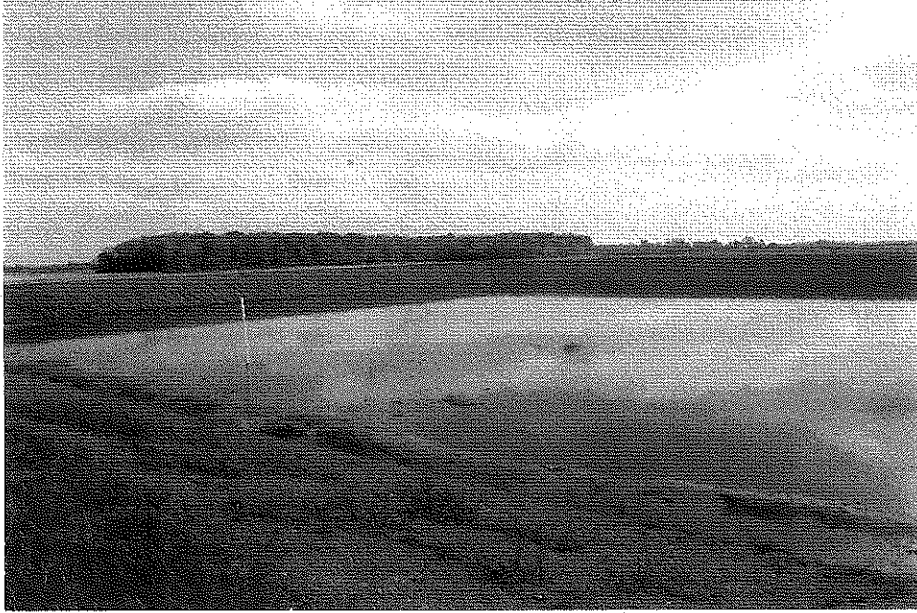
Photo 5: The process wastewater pond and a depth marker, this pond collects all wastewater on the east side of the freestall barns and silage pad. Grass was planted and was starting to come in.
Facing: Northeast

3. Vegetation needs to be established on the berms of the new process wastewater and new earthen manure storage structure. Proper maintenance to the berms of the process wastewater pond and new earthen manure storage structure is required, so that the erosion rills that have formed do not compromise the integrity of the structure.

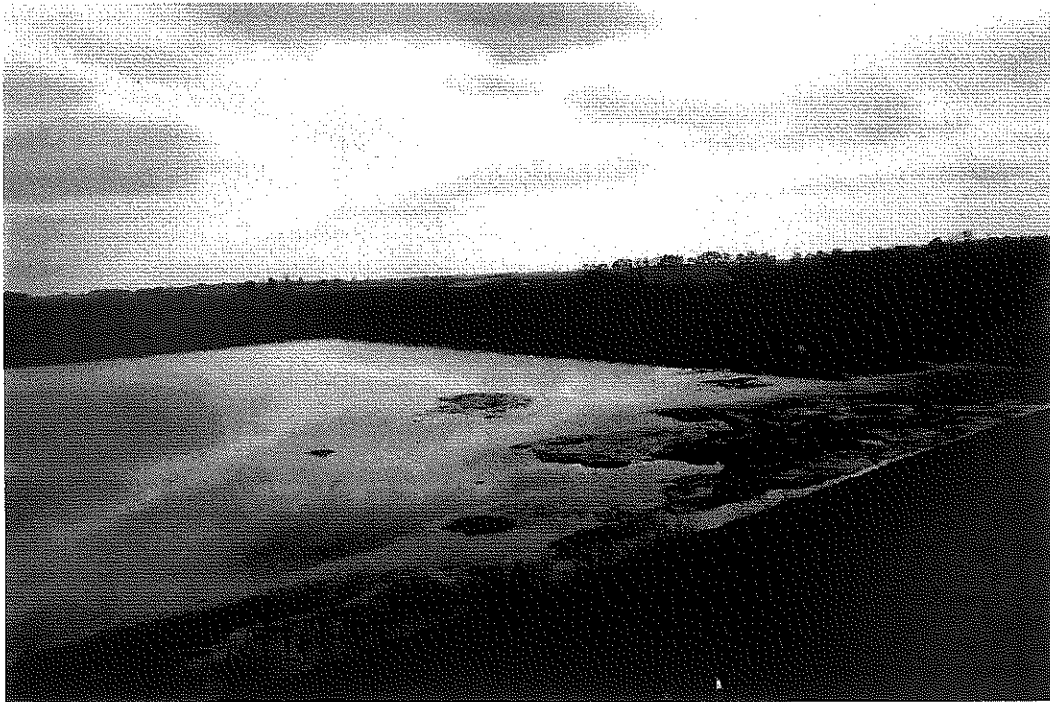
Photo 6: New earthen manure storage structure, which manure is pumped from the old earthen manure storage structure into this new earthen manure storage structure when it gets close to the 2 feet of freeboard.
Facing: South

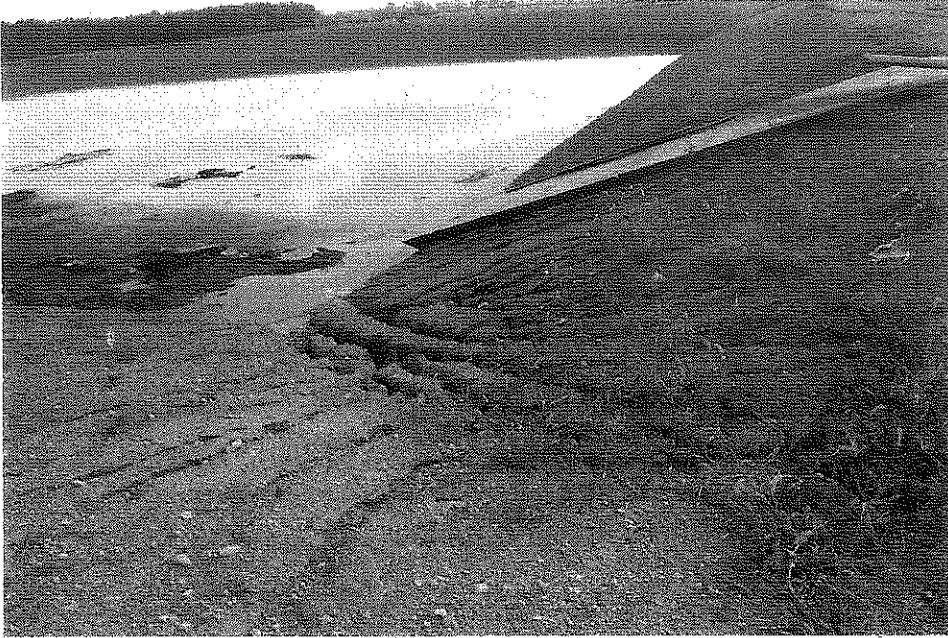
5. Vegetation needs to be established on the berms of the new process wastewater and new earthen manure storage structures. The berms also need to be maintained, so that the rills that have formed do not cause the berm to collapse.

Photo 7: The new earthen manure storage structure has deep rills in the berm, which could cause the berm wall to collapse if not maintained.
Facing: NA

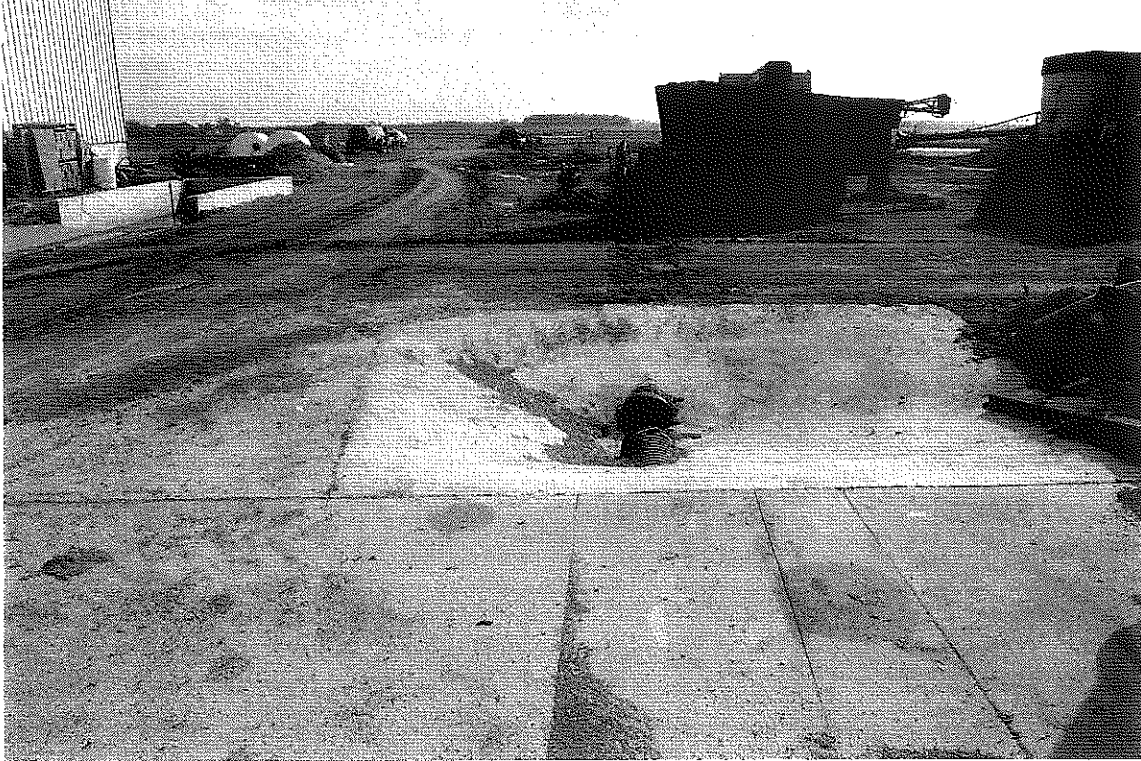
Photo 9: This is the clean water system to drain the roof water away from the production area. Some debris gets into the clean water system, but for the most part is kept pretty clean.
